NATIONAL TRANSPORTATION SAFETY BOARD

Group Chairman's Factual Report

STRUCTURES

DCA13MA120

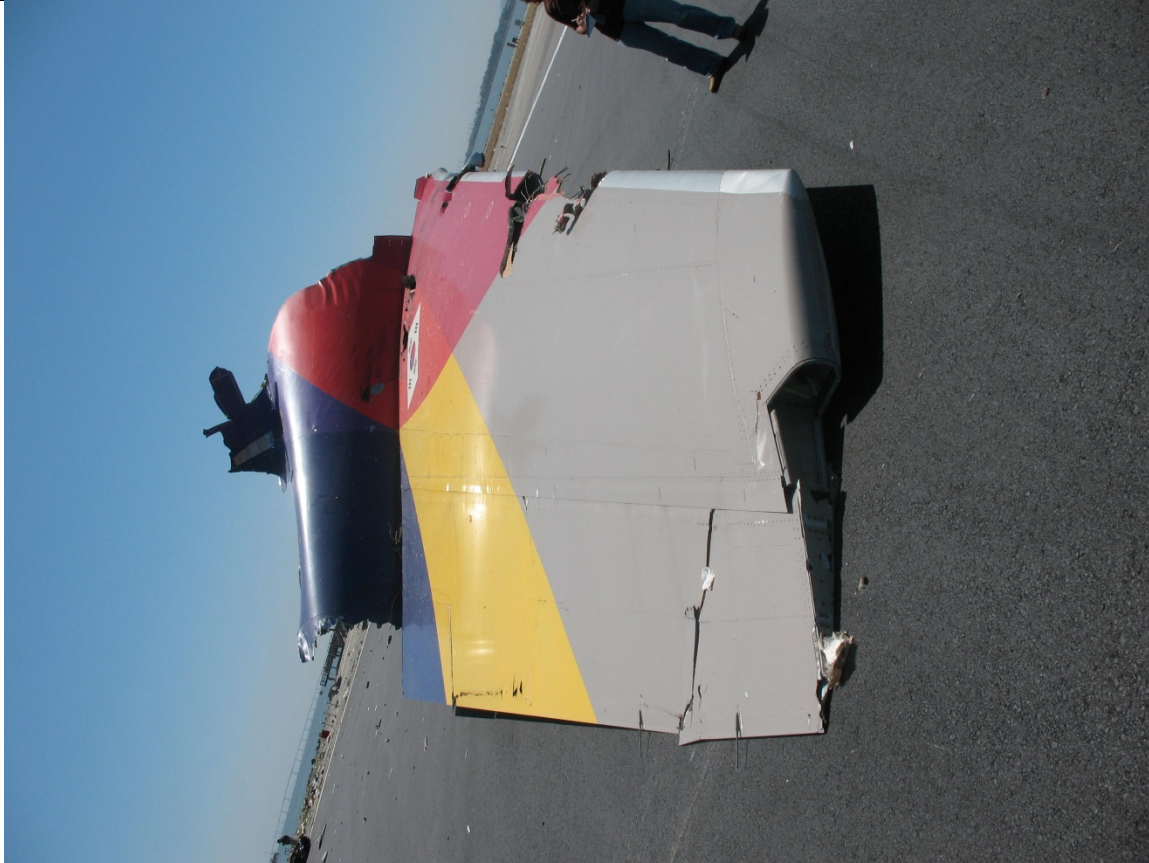
Description: Section 48 crown structure and the vertical stabilizer & rudder.

Photo 23: Section 48 crown structure and the vertical stabilizer & rudder.

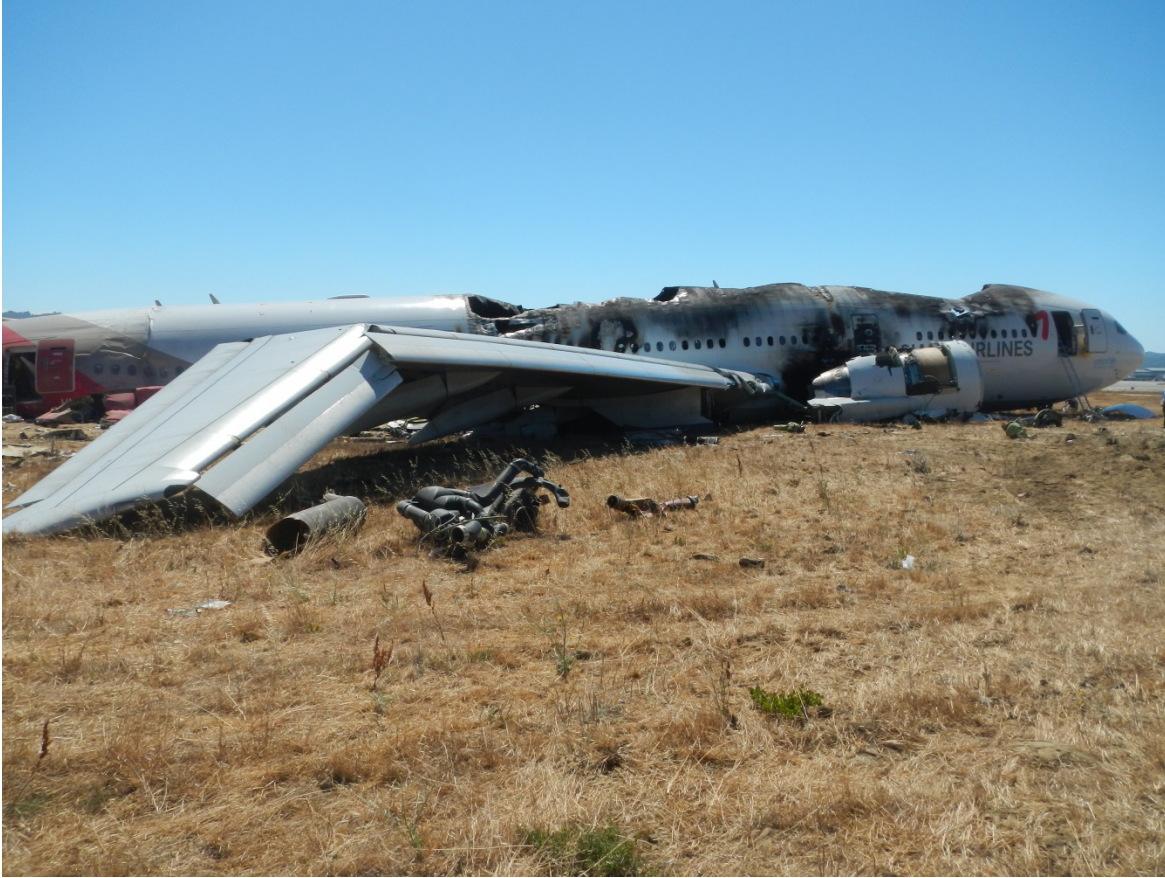
Description: Right hand wing viewed looking inboard.
--

Photo 24: Right hand wing viewed looking inboard.

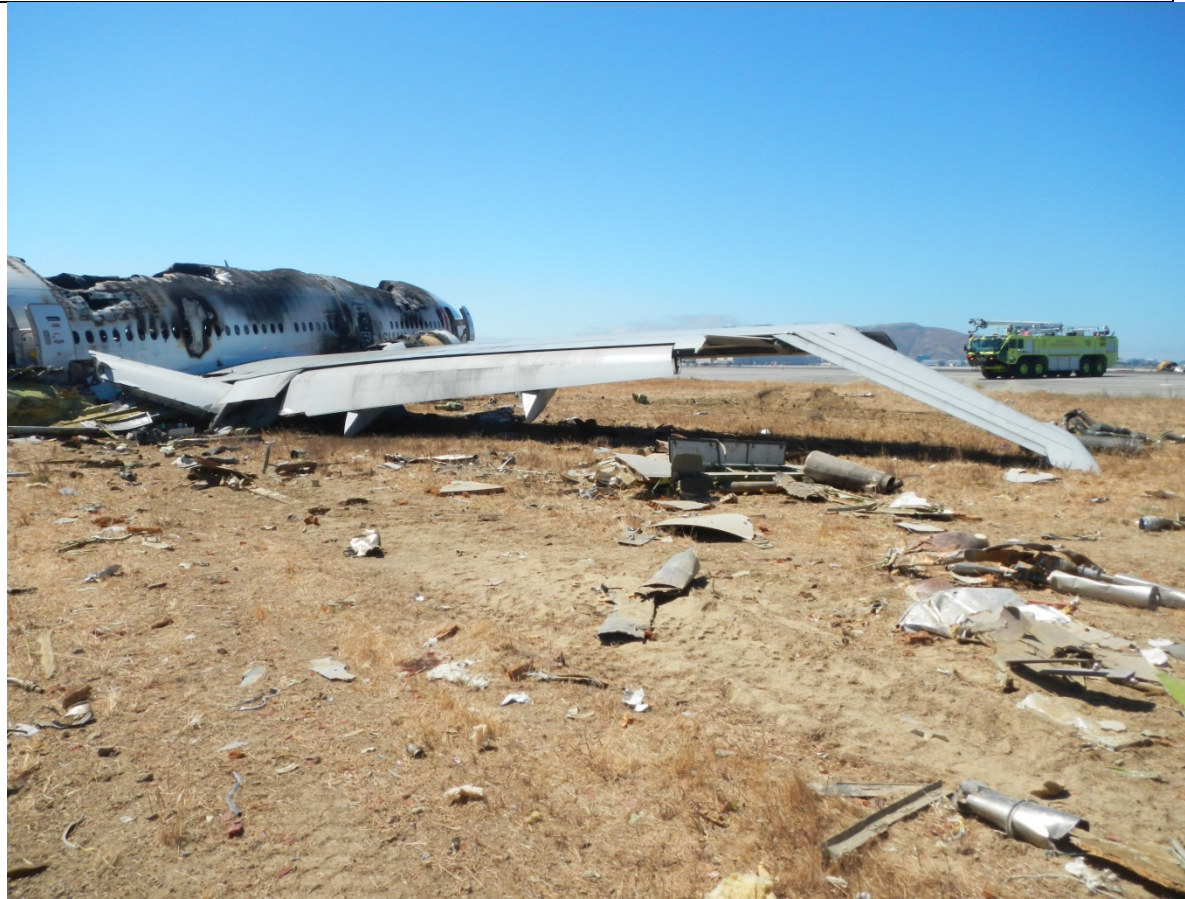
Description: Right hand wing viewed looking forward.
--

Photo 25: Right hand wing viewed looking forward.

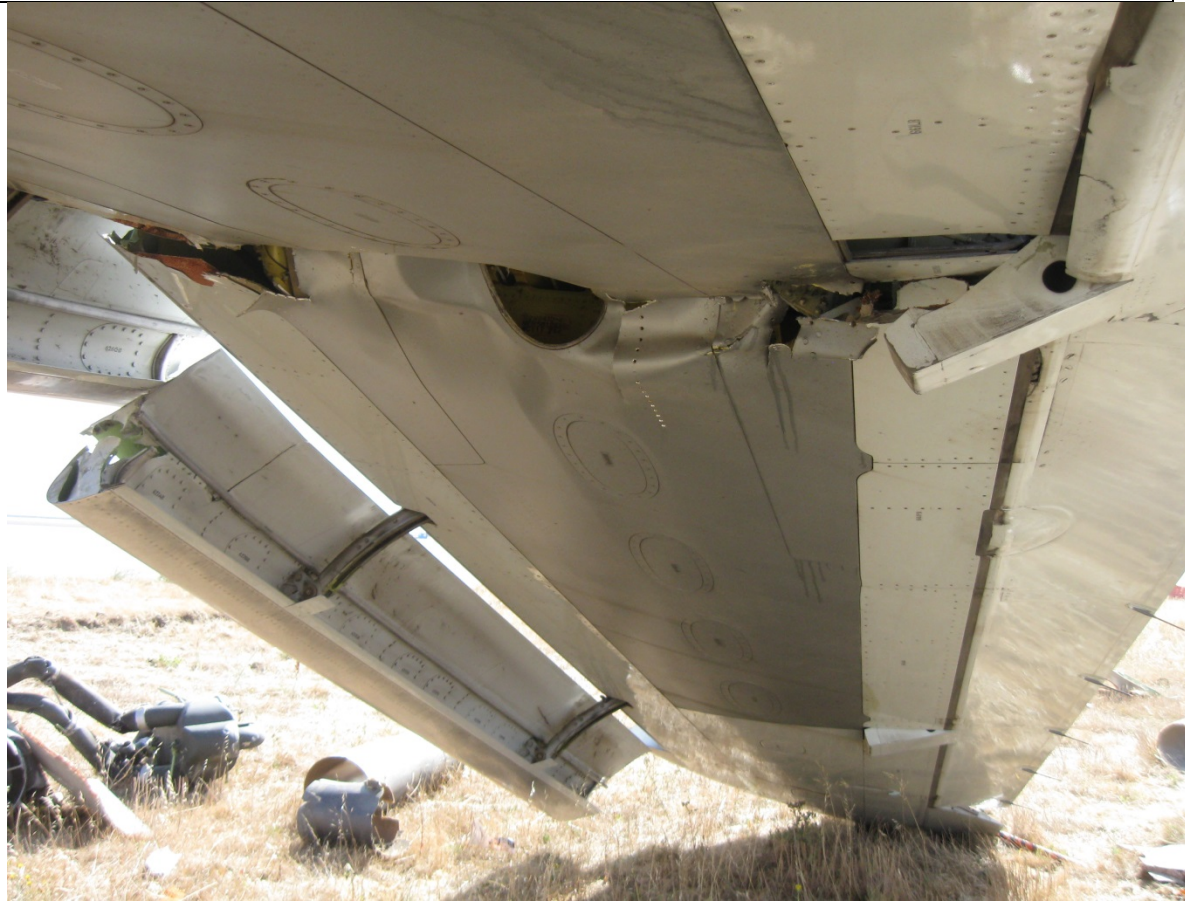
Description: Right hand wing failure at WS 1250 viewed from below.
--

Photo 26: Right hand wing failure at WS 1250 viewed from below.

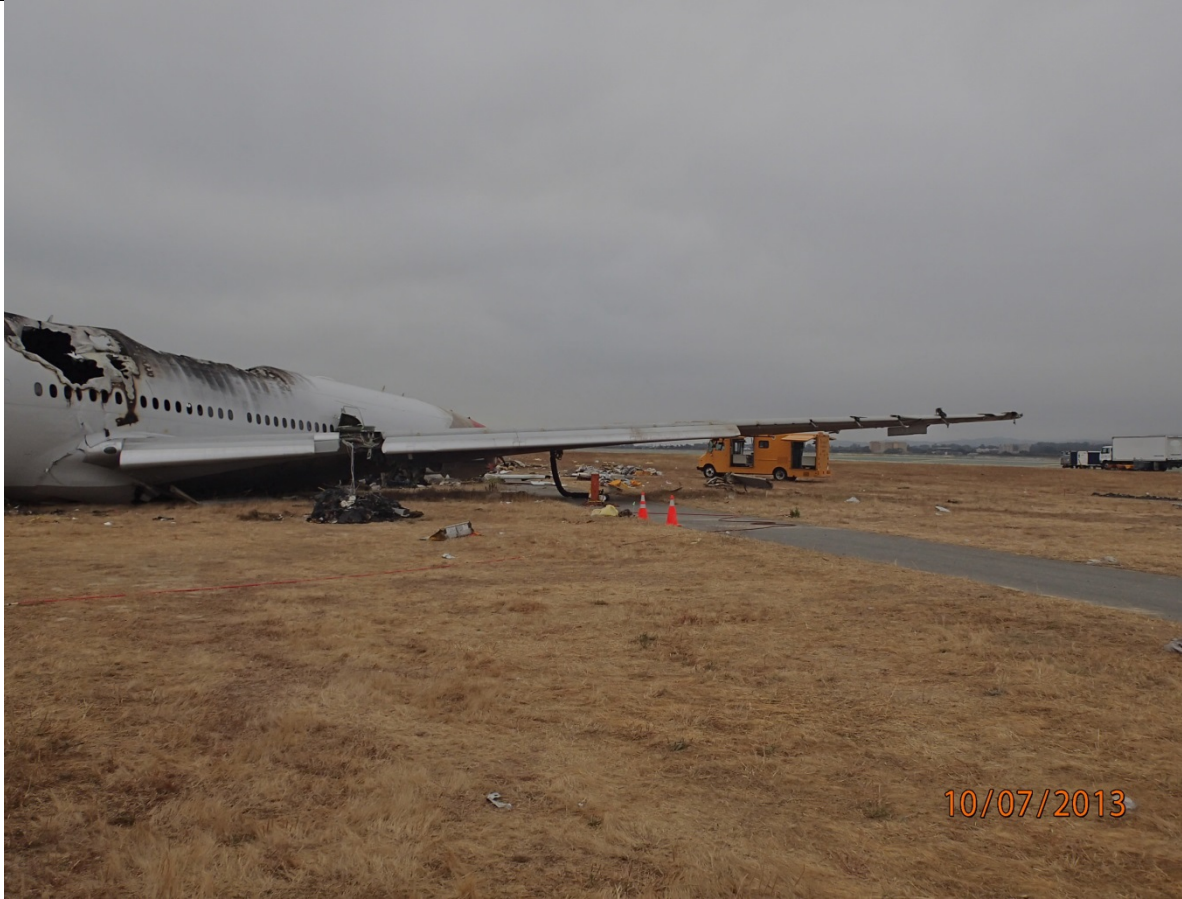
Accident #: DCA13MA120	HL7742
Description: Left hand wing viewed looking aft.

Photo 27: Left hand wing viewed looking aft..

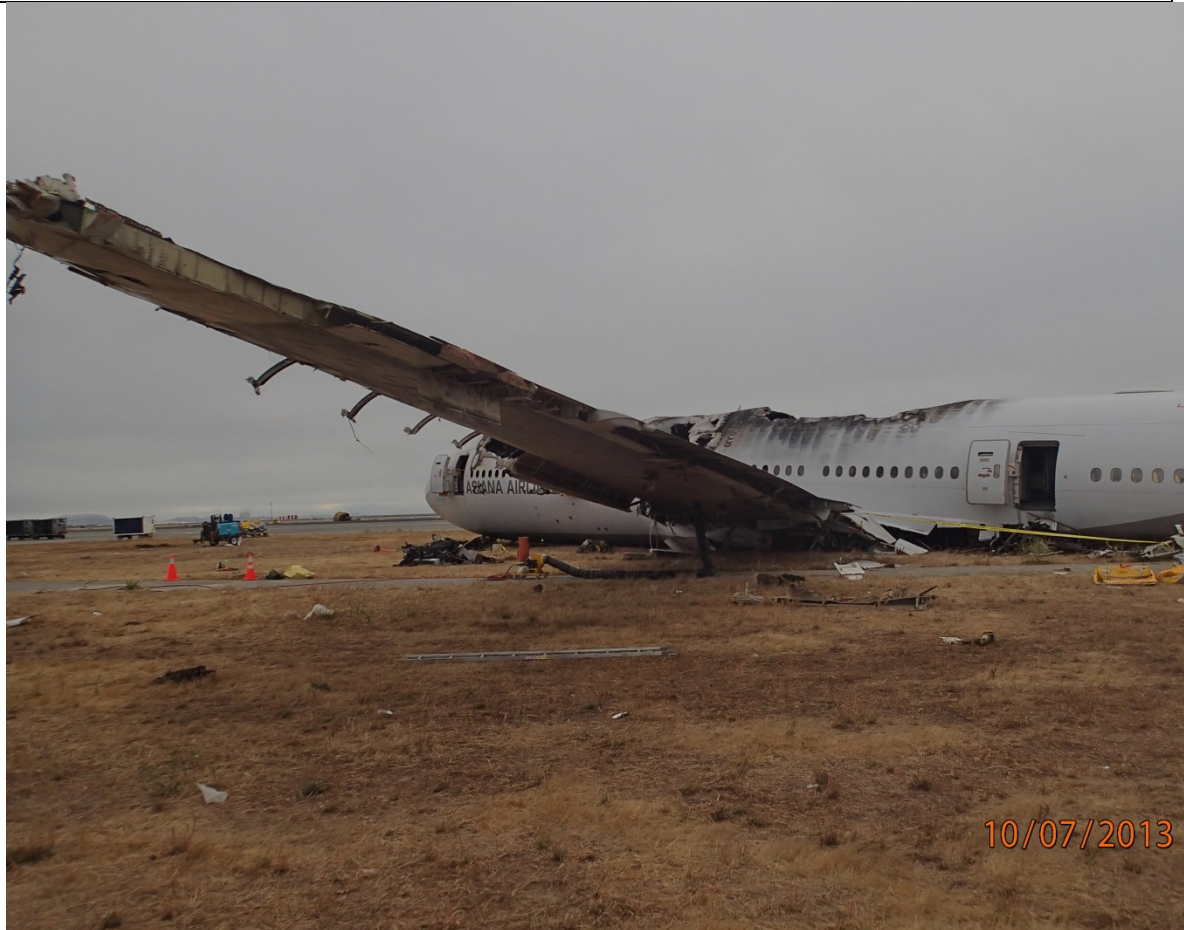
Description: Left hand wing viewed looking forward.

Photo 28: Left hand wing viewed looking forward.
